# Label Locations For TRRO and TRBKTS Options

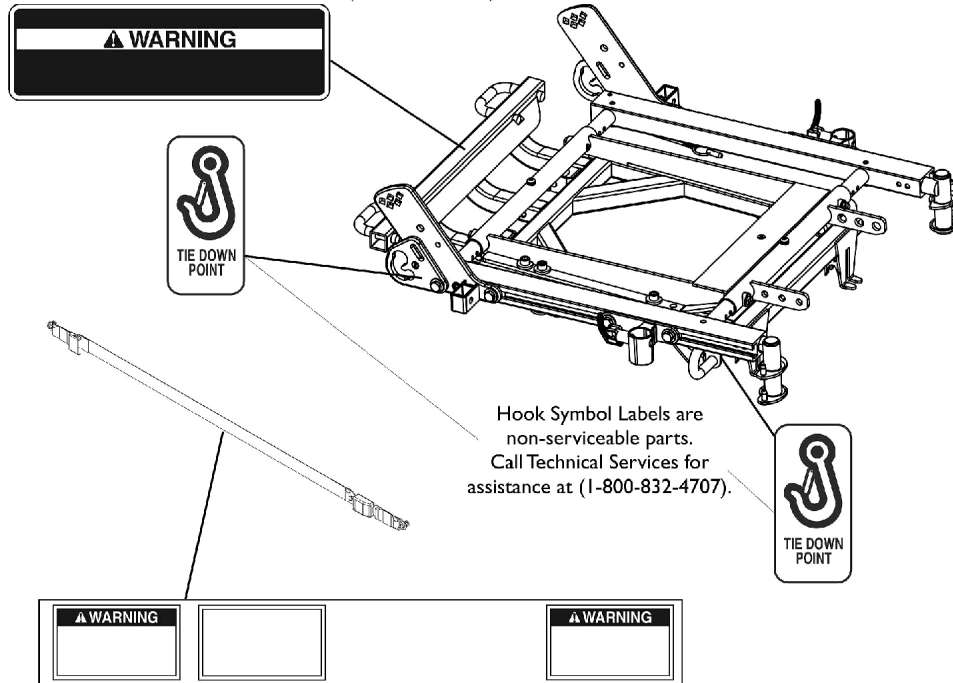
WC/19 Warning Label is a non-serviceable part.  
Call Technical Services for assistance at  
(1-800-832-4707).

Occupant restraint pelvic belt  
conforms with ANSI/RESNA.  
WC/19 Warning Label is sewn  
onto the pelvic belt assembly.

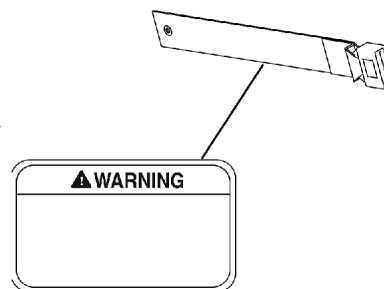
Seat/Chest Positioning Strap  
DOES NOT conform with ANSI/RESNA.  
WC/19 Warning Label is sewn  
onto the positioning strap.
